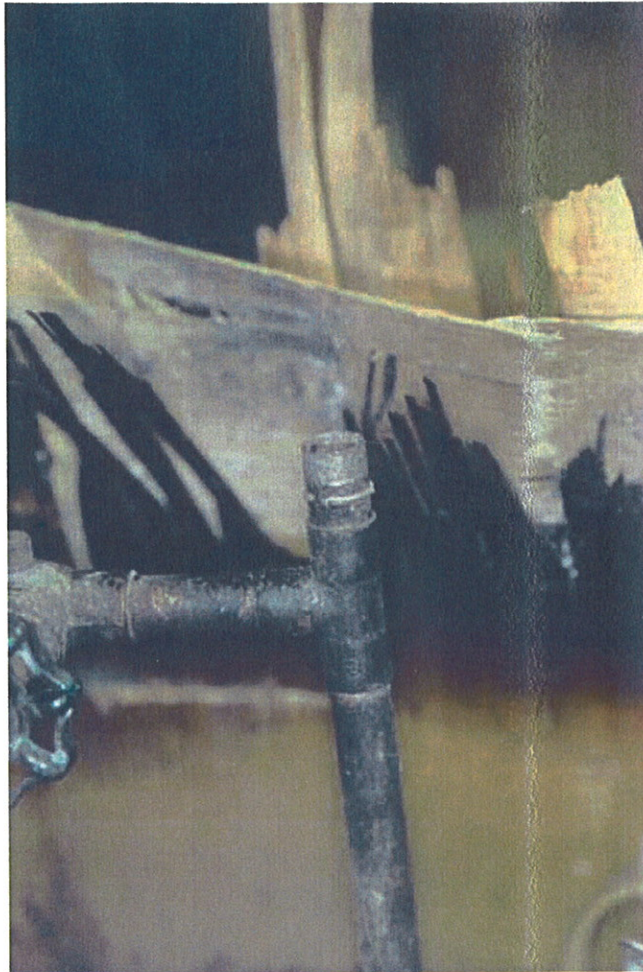
Figure 3. End of copper tubing that was soldered to the brass valve shown in Figure 1.

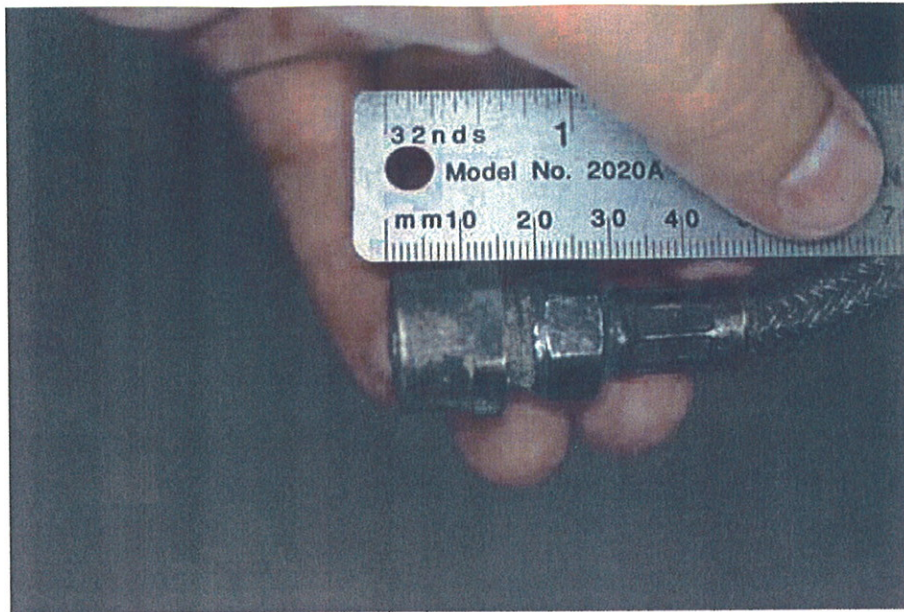
Figure 4. Photograph of the brass fitting that was soldered onto the exposed copper tubing in Figure 1.

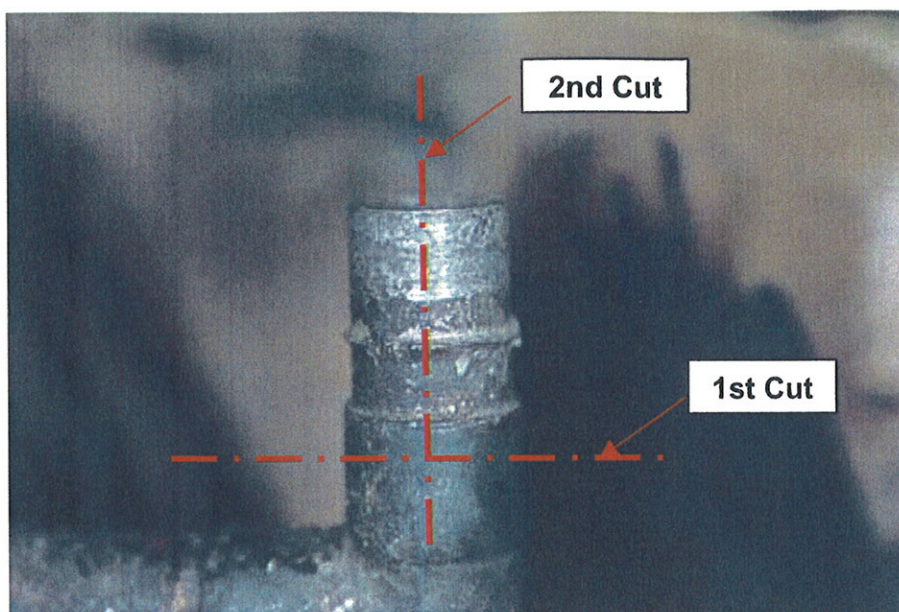
Figure 5. Male joint component that mated to the female joint shown in Figure 6. The red lines indicate where the joint was cut for analysis. This joint section is referred to as "Joint Section 1" in this report.

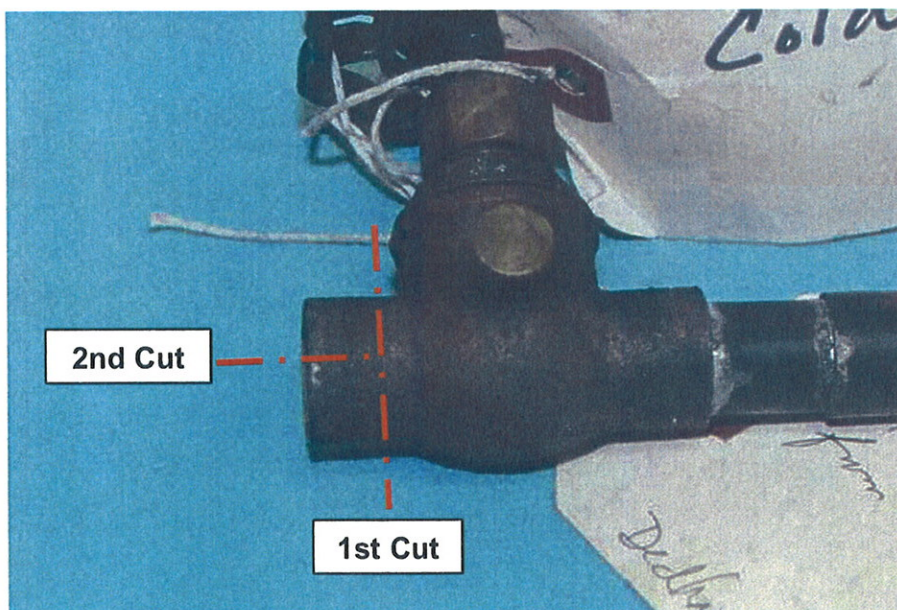
Figure 6. Female joint component that mated to the male joint shown in Figure 5. The red lines indicate where the joint was cut for analysis. This joint section is referred to as "Joint Section 2" in this report.

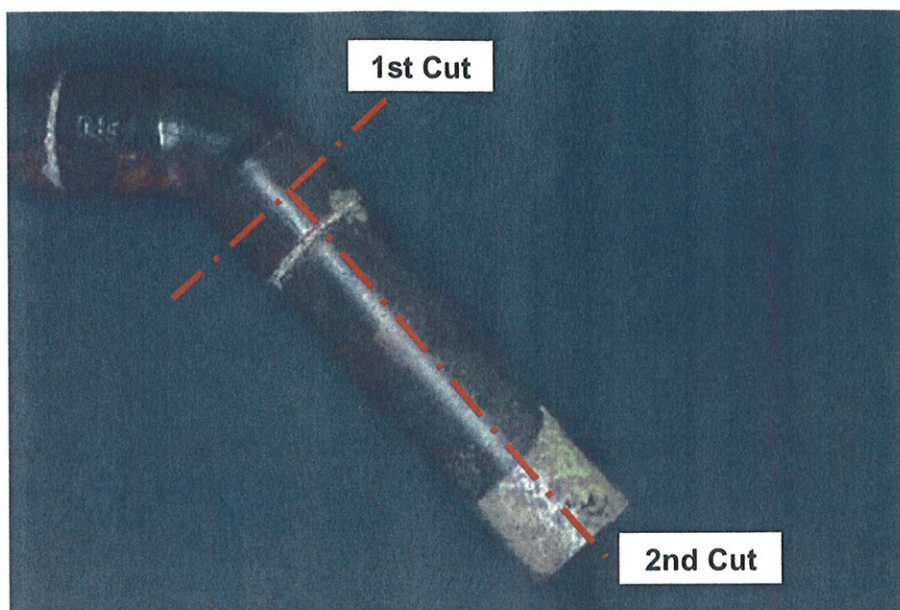
Figure 7. Male joint component that mated to the female joint shown in Figure 8. The red lines indicate where the joint was cut for analysis. This joint section is referred to as "Joint Section 3" in this report.

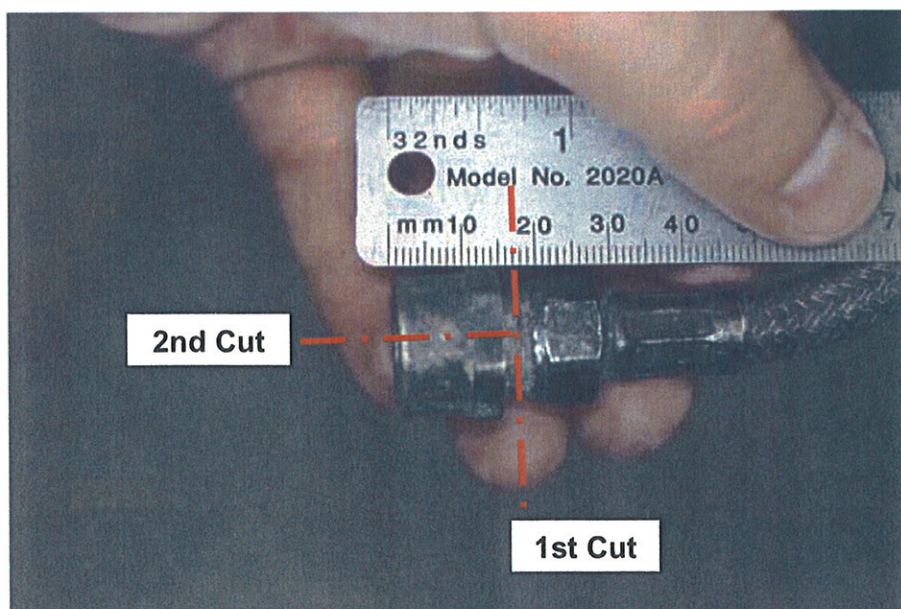
Figure 8. Female joint component that mated to the male joint shown in Figure 7. The red lines indicate where the joint was cut for analysis. This joint section is referred to as "Joint Section 4" in this report.
